Remedy Inspections LLC

Sample Inspection Report

123 Main St USA
Any Town NJ 07000

January 1, 2022

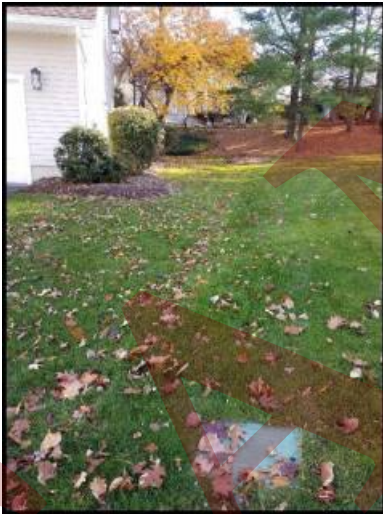
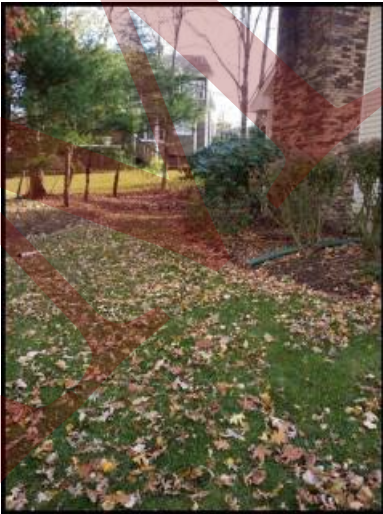
Action Required	Maint Recommend	
2.1 Site Drainage:		
<input type="checkbox"/>	<input type="checkbox"/>	Functional - The lot appears to have adequate drainage to prevent water from ponding. There is a swale installed on both left and right sides to help divert surface water away from the house.
<input type="checkbox"/>	<input type="checkbox"/>

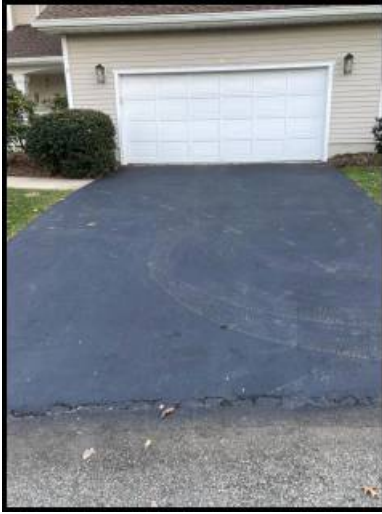
2.5 Driveway Condition:

The driveway surface material is in functional condition with only normal deterioration noted.

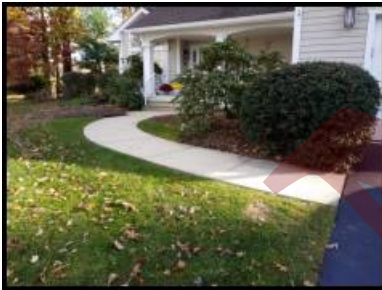
2.7 Walkway Condition:

The walkway surface material is in functional condition with only normal deterioration noted.

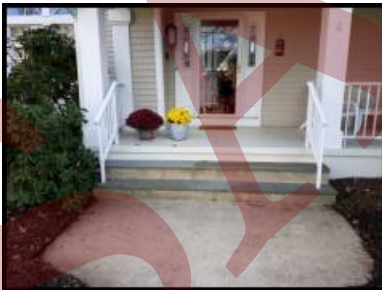
2.8 Entryway Stoop:

The entryway stoop is in functional condition.

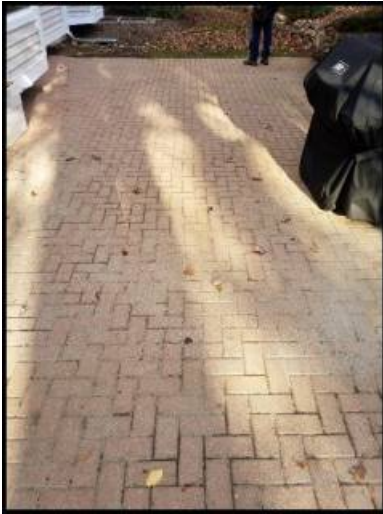
2.9 Patio Slab Materials:

Brick.

Attention Needed - The slab is in useable condition however there is evidence of ponding and it appears hydraulic pressure from the hill behind the house has caused the patio to become sloped toward the house. This presents an issue as water is flowing toward the foundation and not away. Recommend having the patio re-graded to drain away from the house by a qualified professional.

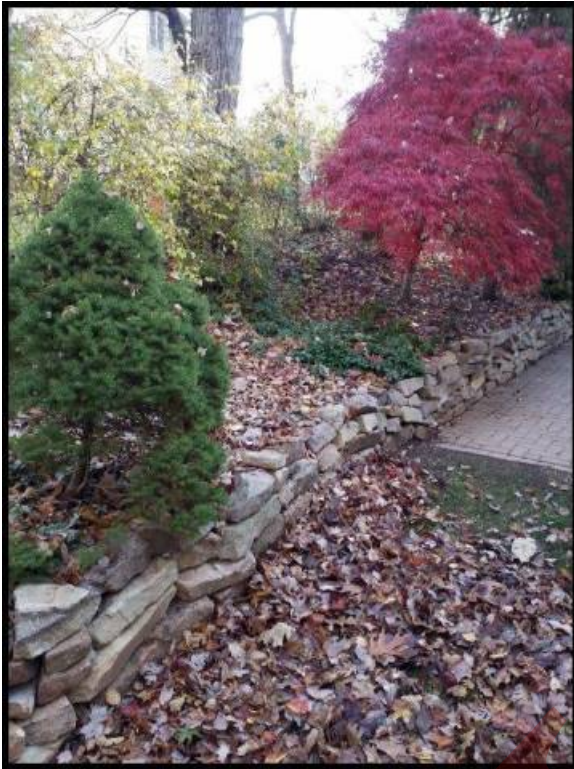
2.14 Materials Used:
 The retaining wall is made of stacked rock.

2.15 Condition of Wall and Materials Used:
 The retaining wall is in functional condition.

Attention Needed - As noted above the run-off water above the retaining wall needs to be redirected away from the patio and house.

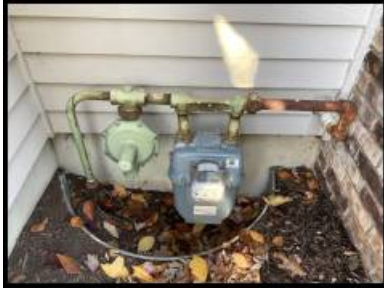
2.22 Location of Meter:

Right side of the house.

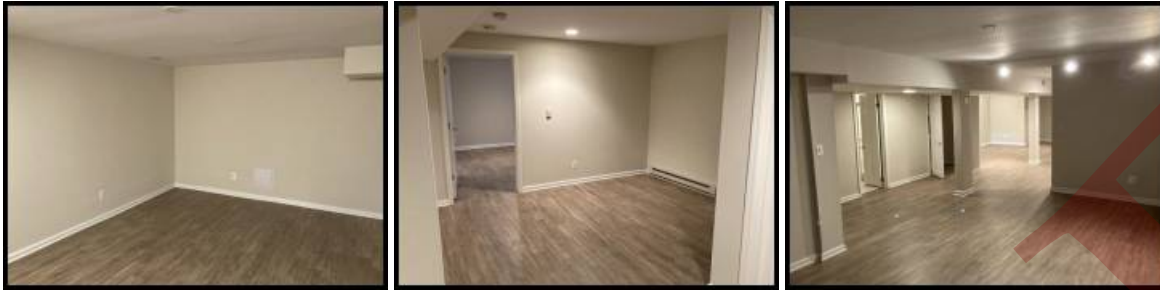
3.5 Interior of Basement Percentage Finished Into Living Space:

Approximately 100% basement is finished into living space. The living space is approximately at grade level.

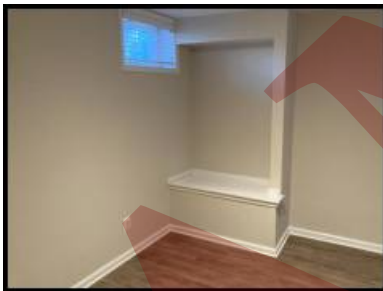
3.11 Basement Windows:

There are basement level windows. The windows as installed appear to be functional.

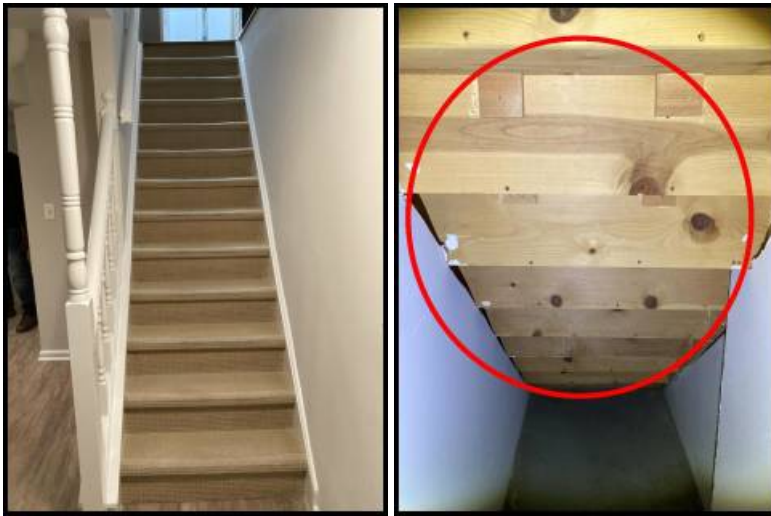
Attention Needed - The underside of the stair case is not enclosed with fire rated drywall. This is a requirement in modern building standards in case of a fire. Recommend adding this protection. Consult a qualified professional to install.

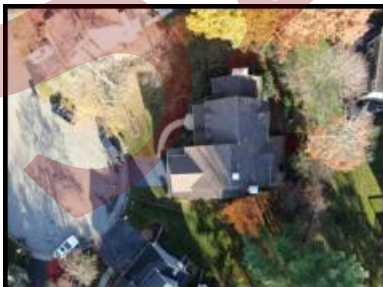
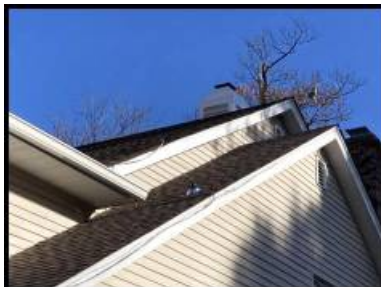
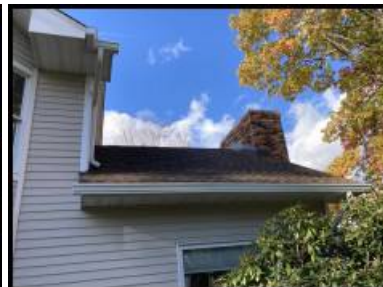
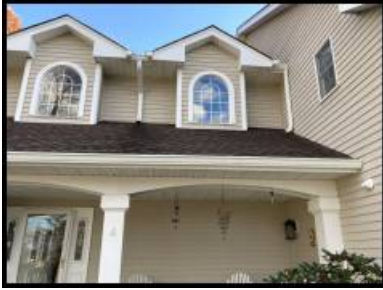
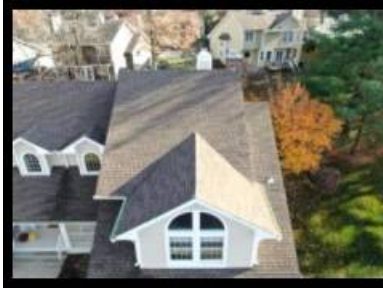
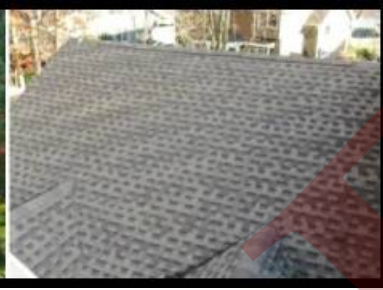
4.3 Condition of Roof Covering Material:

Good - The roof covering material is either new or near new, and it appears to be installed correctly.

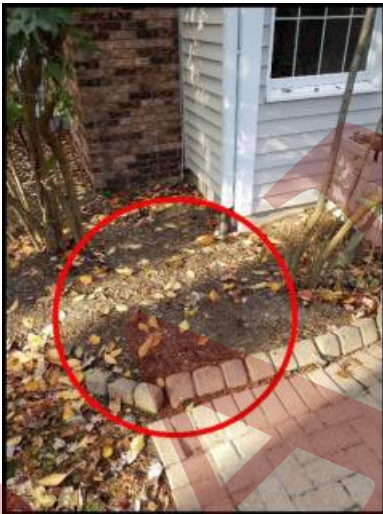
Attention Needed - The home is fully guttered. The gutter system on the roof edge appears to be functional and adequately sloped to carry the water to the downspouts, Some of the downspouts go into an underground system. I was unable to determine where they empty and if they are functional. Run-off water needs to flow away from the side of the house at least 6 feet. This will allow the run-off to get far enough away to not interfere with the foundation. Installation of downspout extensions would help carry the water further away from the foundation.

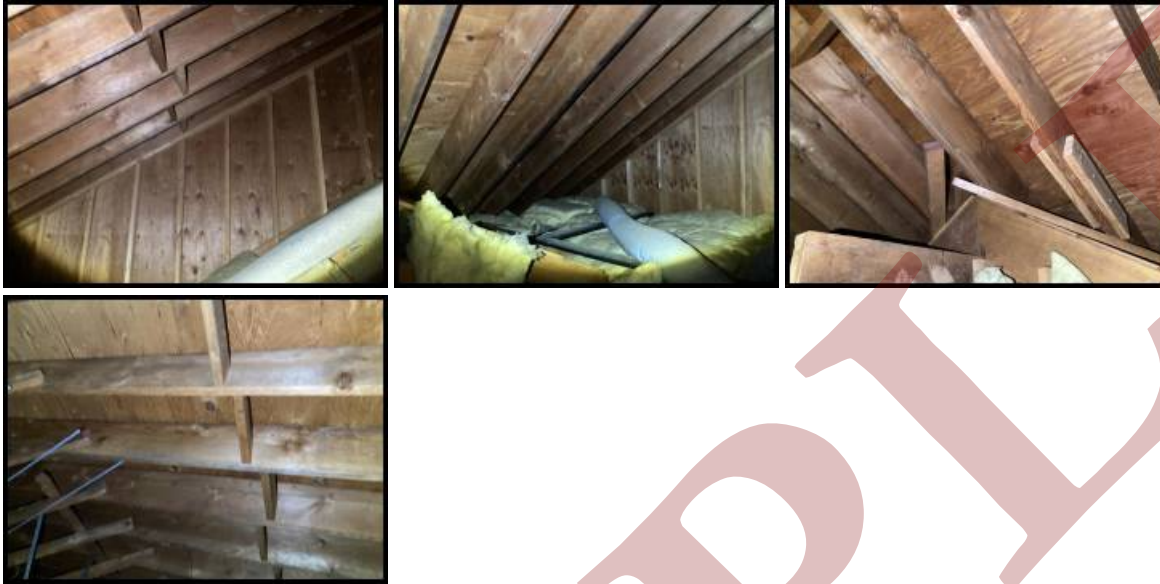
4.11 Roof Framing:

A rafter system is installed in the attic cavity to support the roof decking. The rafter spacing is 16 inch on center. The rafters system appears to be in functional condition.

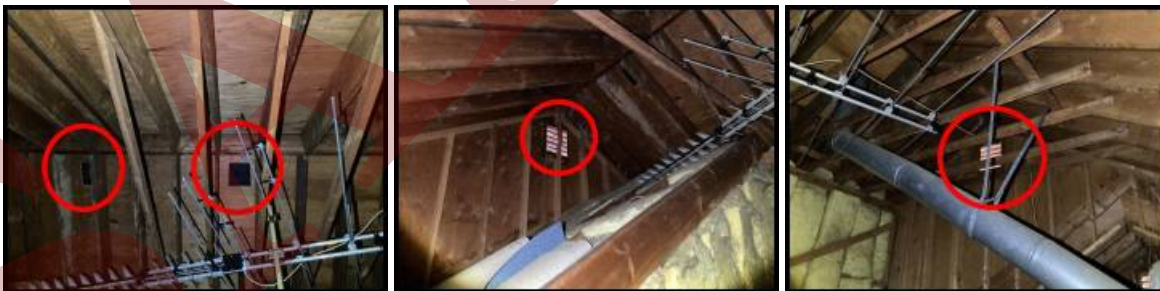
4.16 Ventilation Hi/Low:

There are ridge vents installed. There are soffit vents installed. There are gable end vents installed that allow adequate ventilation.

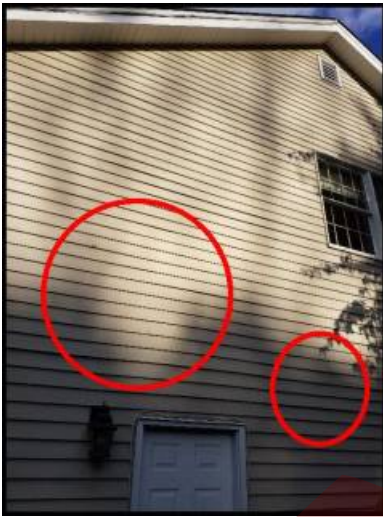
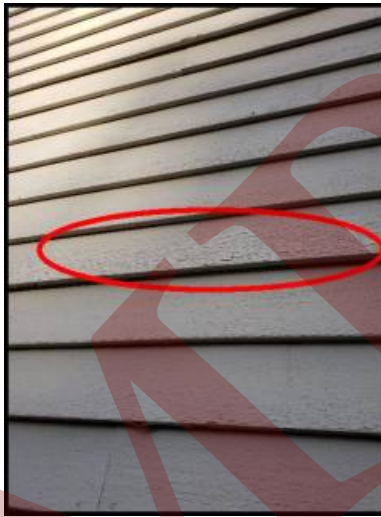
Attention Needed - The majority of the siding is in serviceable condition. The exterior siding material on the right side of the house is in a condition that requires minor repair to prevent further deterioration. Paint is peeling and cracking from sun exposure. Recommend repairing and repainting by a qualified professional.

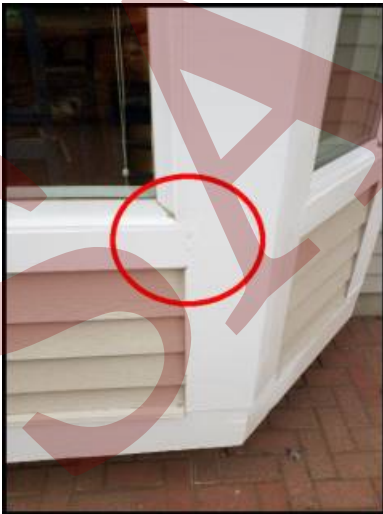
5.3 Trim Condition:

Attention Needed - The trim needs some minor repair to prevent further deterioration. Some portion of the trim on the rear of the house near the patio is deteriorated to the point that it needs replacement. Recommend repairing and repainting by a qualified professional.

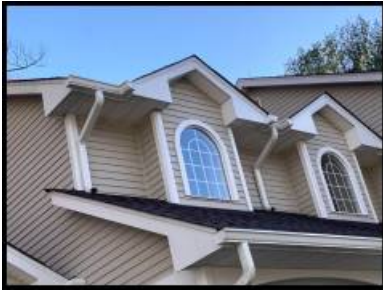
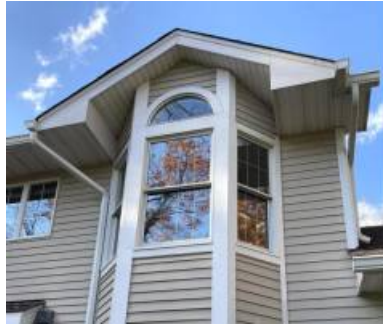
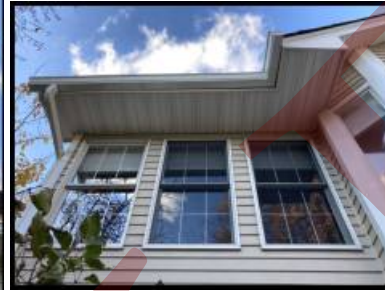
5.4 Soffit/Eaves:

The soffit/eaves appear to be adequate and show only signs of normal wear.

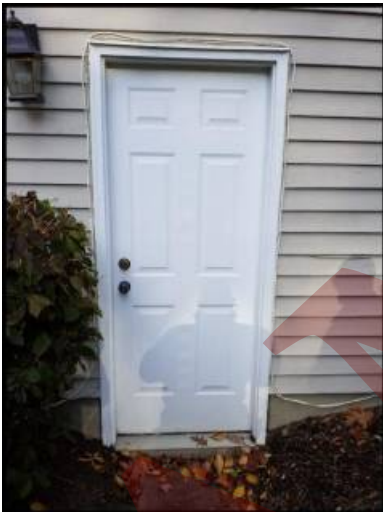
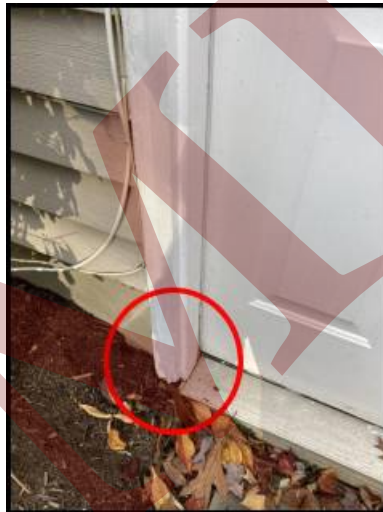
5.6 Outside Entry Doors:

Attention Needed - The outside entry door from the garage is functional as noted from the exterior however door needs some minor adjustment or repair. The frame is rotted on the bottom where it has made contact with the ground. Recommend repairing and repainting by a qualified professional.

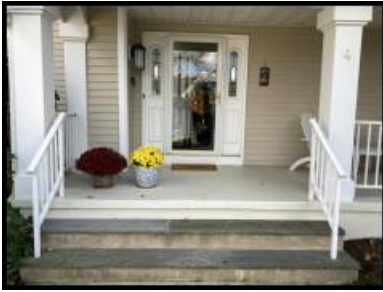
5.9 Structure Type:

Front porch.

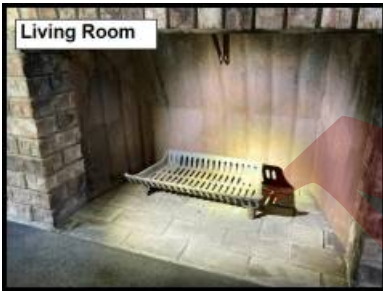
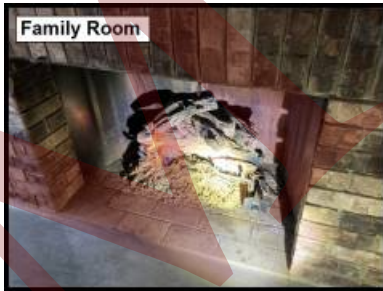
5.15 Location of Fireplace:

Living room, Family Room.

Metal Firebox - There is a masonry fireplace installed with a metal formed firebox.

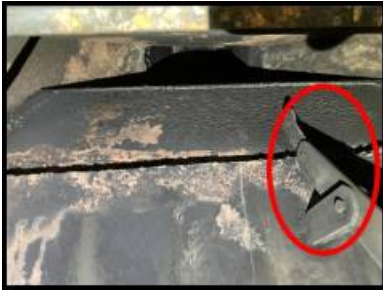
5.19 Damper Condition:

Living Room - The flue damper appears to be functional and fully adjustable.
Attention Needed - Family Room. There is no damper clip installed. All fireplaces with a gas connection should have a clip installed that will allow a small airflow up the chimney.

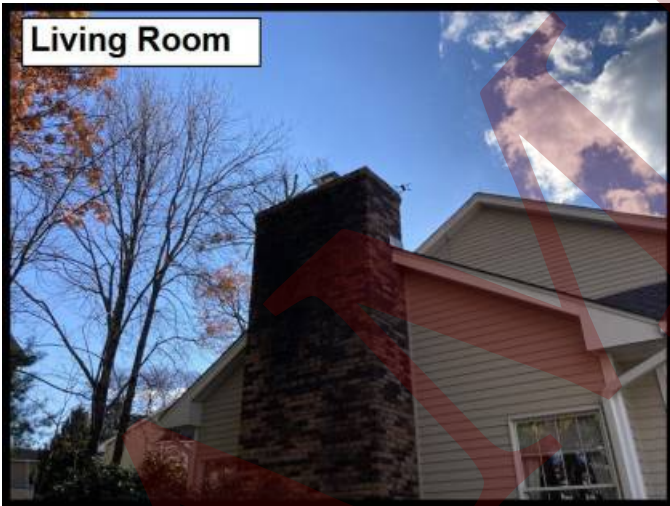
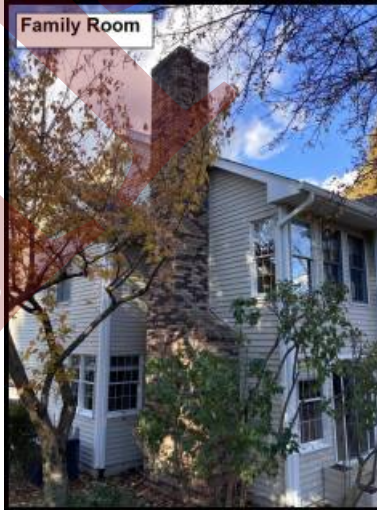
5.23 Exterior Stack Condition:

The exterior stacks appear functional.

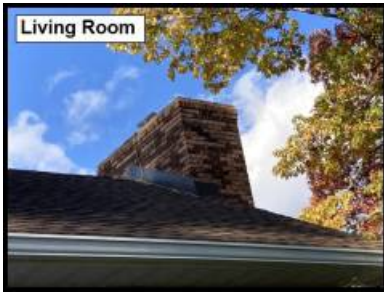
5.28 Flashing:

The installed flashing around the chimney stack appears to be functional.

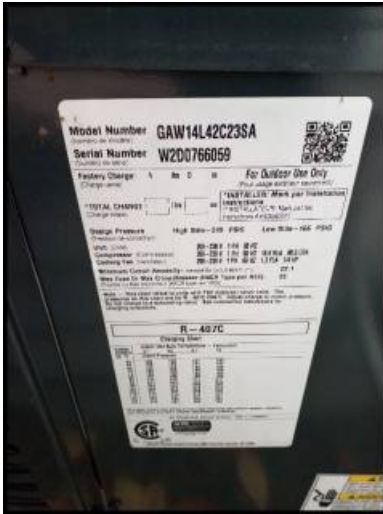
System is Evcon.
 Model #:GAW14L42C23SA
 Serial #:W2D0766059
 Date of Mfg: Sept 2020.

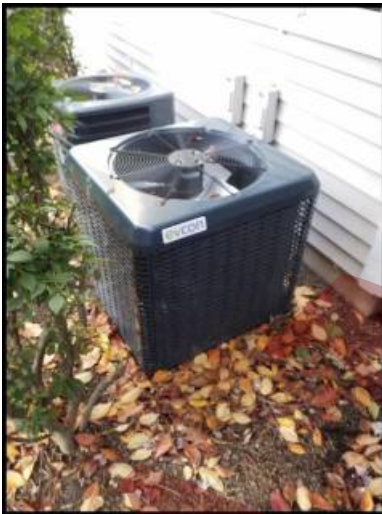
6.2 Type and Location:

A central air conditioning system is installed that uses a condenser and compressor located on the exterior of the house that pumps refrigerant to an evaporative coil located in either an air handler or furnace which then distributes the cooled air throughout the home using ductwork.

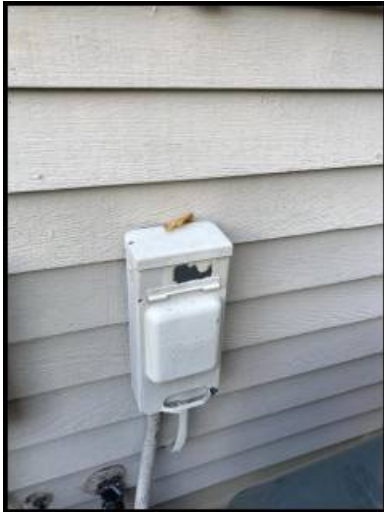
The installed service disconnect is located within sight of the condensing coil cabinet and not more than 50 feet from the unit.

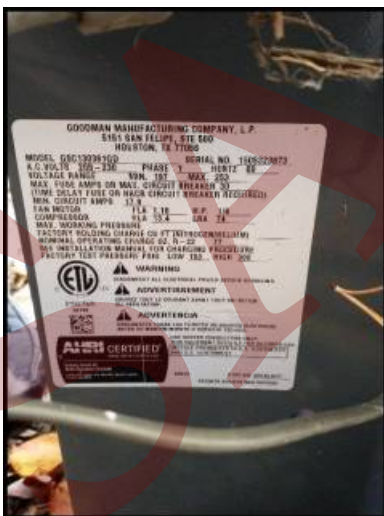
Serial #: 1505323873

Date of Mfg: May 2015.

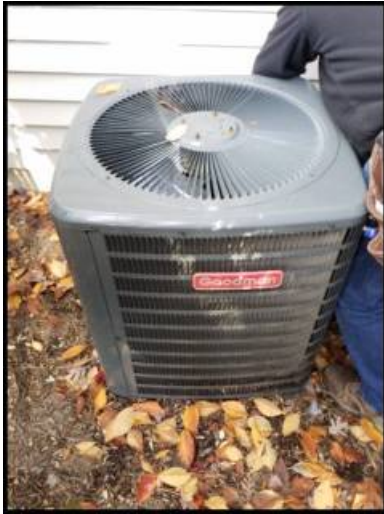
6.12 Type and Location:

A central air conditioning system is installed that uses a condenser and compressor located on the exterior of the house that pumps refrigerant to an evaporative coil located in either an air handler or furnace which then distributes the cooled air throughout the home using ductwork.

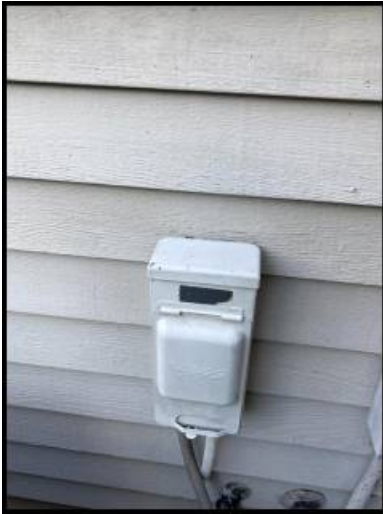
6.18 Service Disconnect:

The installed service disconnect is located within sight of the condensing coil cabinet and not more than 50 feet from the unit.

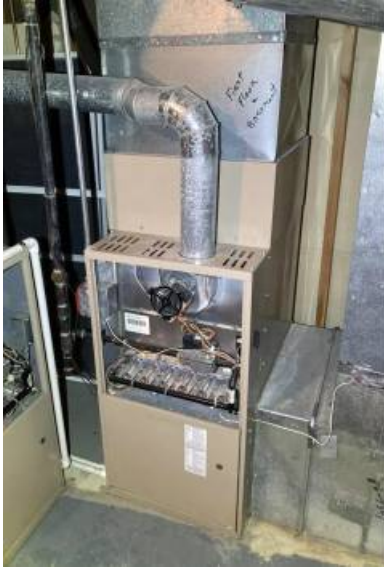
6.26 General Operation & Cabinet:

Unit was operational at the time of inspection. General condition appears serviceable.

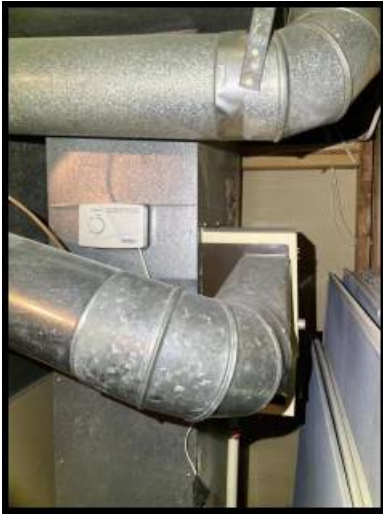
Yes, there is a humidifier installed. If functioning properly, it can add comfort to the home during the heating season. The scope of this inspection does not include determining if the unit is operational since activation is humidity controlled. Most units will require service annually.

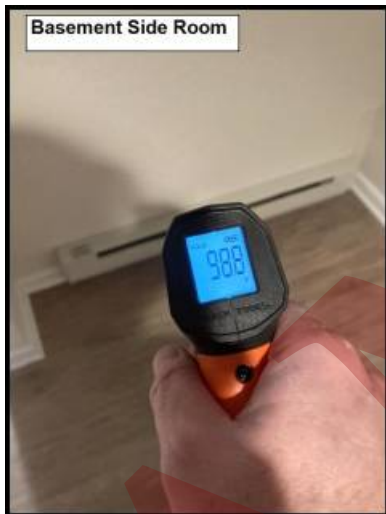
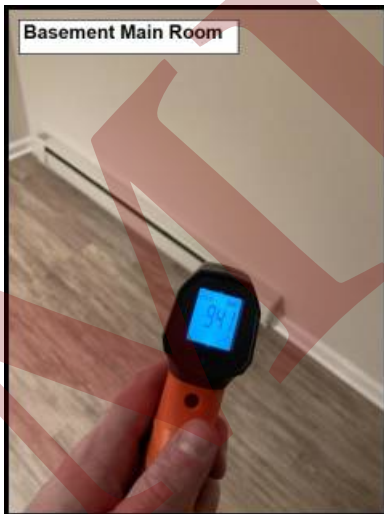
6.30 Electric Baseboard Heat:

There is electric baseboard heating strips installed in the basement main room and side room. They appear to be correctly installed and functional.

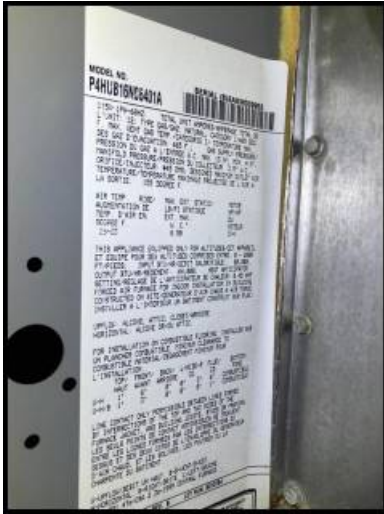
6.34 Equipment Description:

System is York brand.
Model #: P4HUB16N06401A
Serial #: EAKM009953
Date of Mfg: Jan 2001.

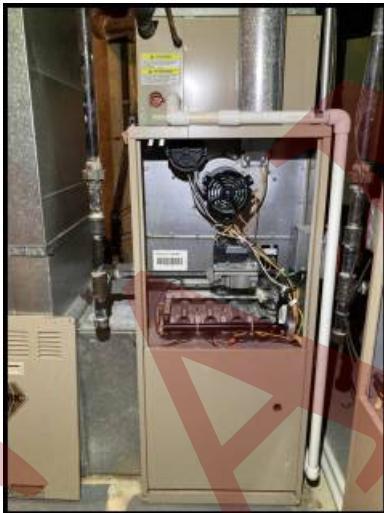
6.37 General Operation & Cabinet:

Unit was operational at the time of inspection. General condition appears serviceable.

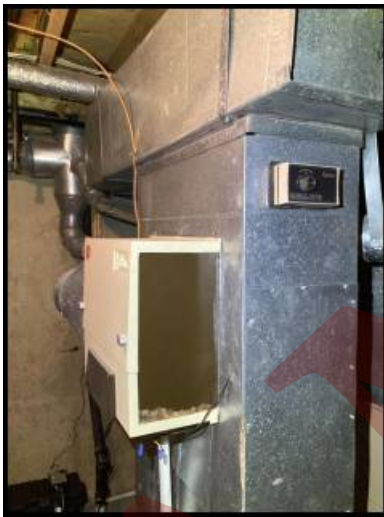
6.41 Humidifier Installed:

Yes, there is a humidifier installed. If functioning properly, it can add comfort to the home during the heating season. The scope of this inspection does not include determining if the unit is operational since activation is humidity controlled. Most units will require service annually.

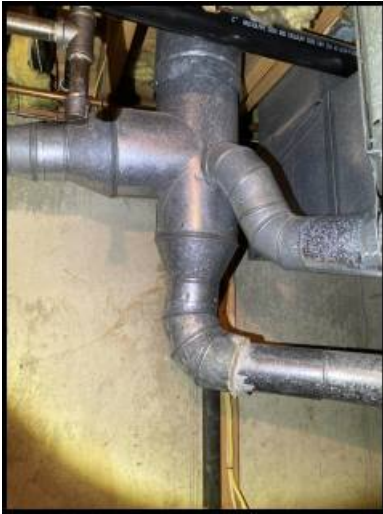
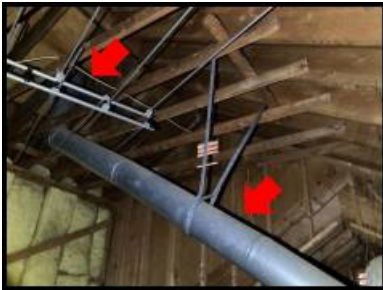
6.43 Type of Chimney:

The chimney is primarily built of metal such as steel or an alloy.

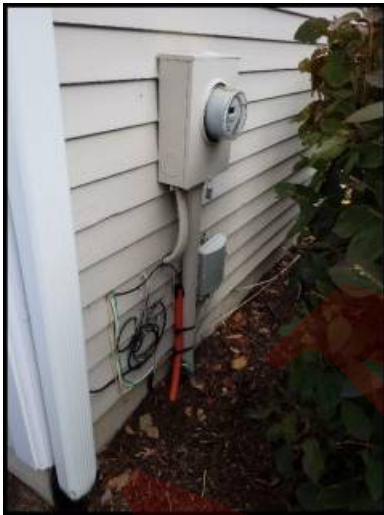
7.1 Type & Condition:

Underground.

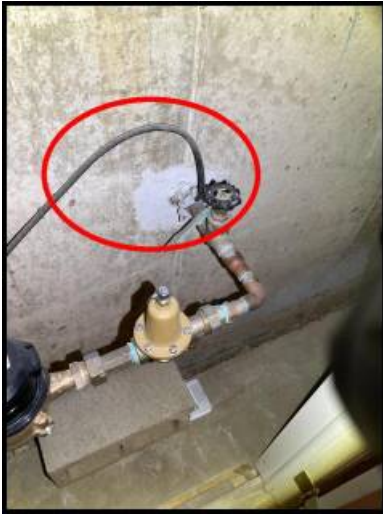
7.2 Main Service Ground Verified:

Yes - The main service ground wire was located by the inspector. Grounding provided by connection to metallic water pipe.

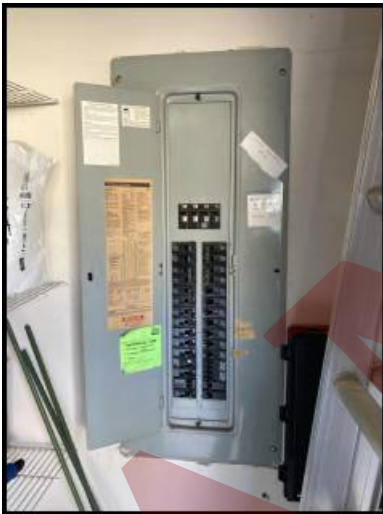
7.3 Main Panel Location:

Garage.

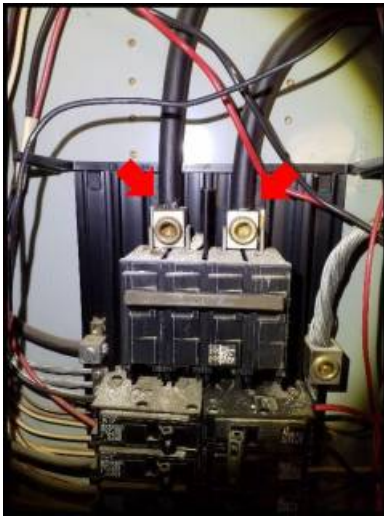
7.7 Entrance Cable Size:

4/0 Aluminum.

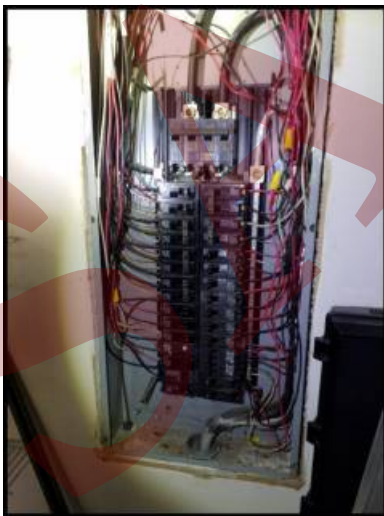
Action Necessary - Damage/defects noted, Double Taps - this condition is where multiple wires are connected to a single lug on a circuit breaker where only one wire should be connected. The risk of a poor connection is greater here. Multiple wires are joined into single posts on the neutral bus bar. It is recommended that a licensed electrician evaluates and/or repair the panel deficiencies noted above prior to the end of your inspection date.

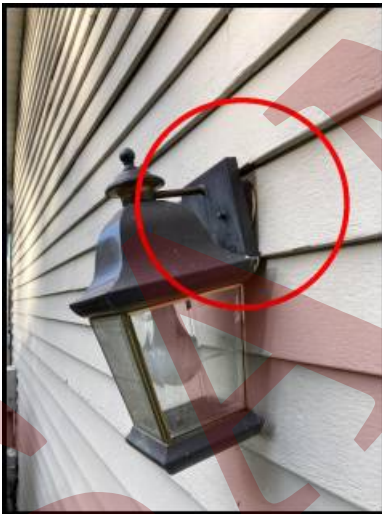
7.23 Exterior Lighting:

Attention Needed - Some portion of the exterior security lighting is not functioning as intended. This light fixture on the right side near the exterior garage door is not mounted correctly. This poses a risk of electric shock. Recommend having a licensed electrician evaluate and correct the condition.

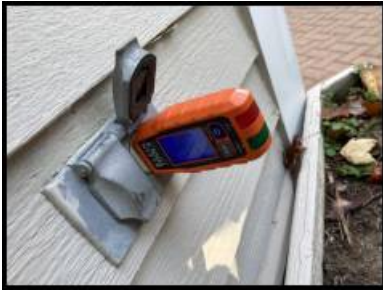
7.24 Patio:

Yes. The outlet is Ground Fault Circuit Interrupt protected.

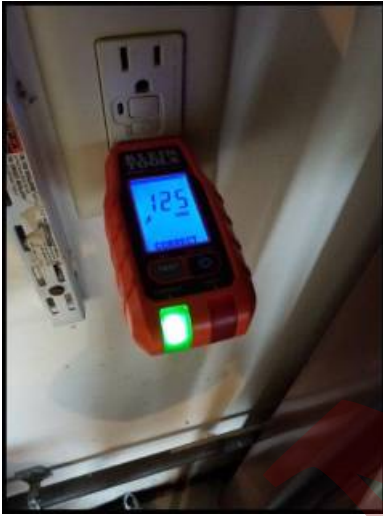
The electrical outlets in the garage tested as correctly grounded. The garage electrical outlets, except for dedicated circuits, are protected with Ground Fault Circuit Interrupt protection as required by current standards.

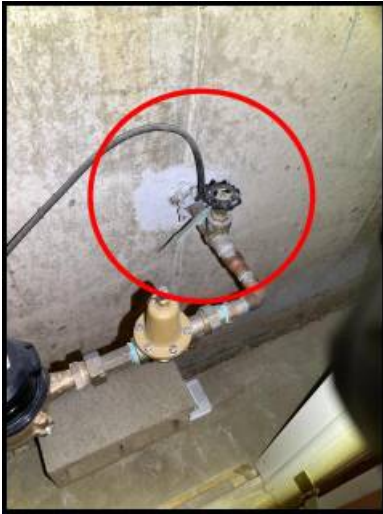
- 8.1 Water Source:**
 City/Municipal.
- 8.2 Plumbing Service Piping Size to Structure:**
 1" water service line from the meter to the main cutoff.
- 8.3 Public Service Piping Material:**
 The main service line to the structure is copper.

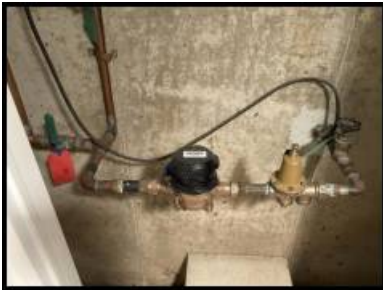
Action Required Maint Recommend
8.4 Main Water Line Cutoff Location:

Basement level front left wall.

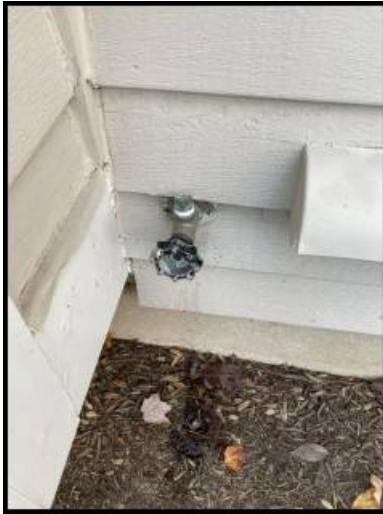
The exterior hose bib(s) appeared to function normally. The external hose bibs are frostproof. Do not leave garden hoses connected to hose bibs when freezing temperatures are possible. Damage to the valve or piping could result.

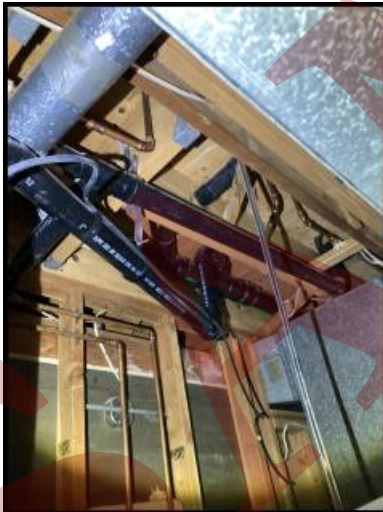
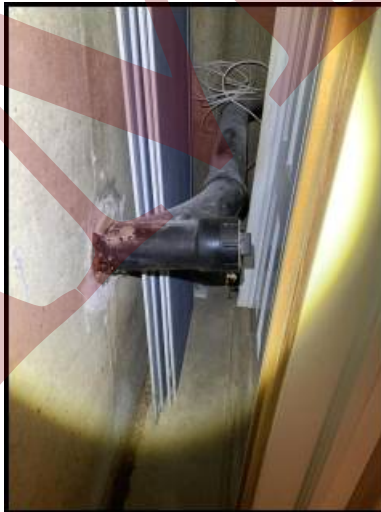
8.13 Waste Piping Condition:

The visible plumbing waste piping appears functional.

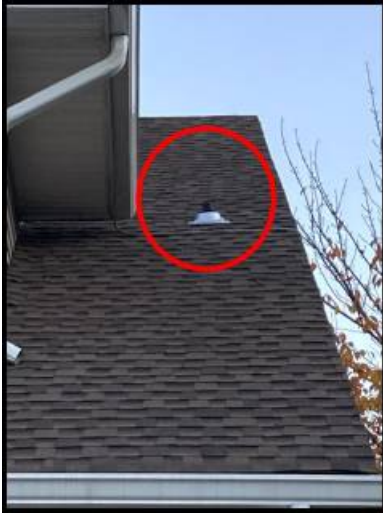
Attention Needed - Some portion of the visible plumbing vent stack needs attention. The plumbing stack vent does not protrude a minimum of 12" above the roof surface. This condition may allow snow and ice to block the top of the vent, thereby not allowing the plumbing to drain properly. Recommend this condition be corrected by a licensed plumber prior to closing.

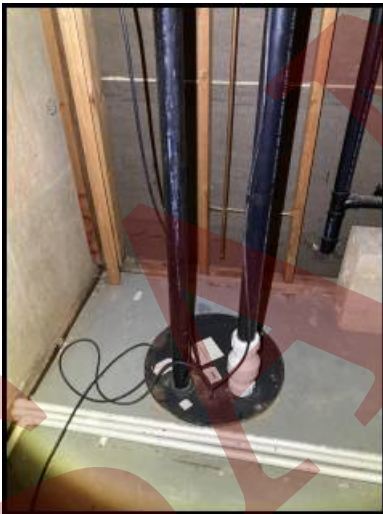
Yes - There is a sewage pump installed in the basement utility room. This is needed either because of elevation of lowest fixture in relation to the sewer line or because of the distance to the sewage main. This unit requires periodic maintenance and should be connected to an alarm to warn of failure. The pump appeared to function at the time of the inspection.

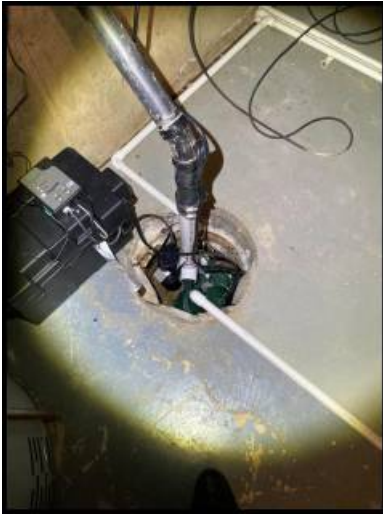
8.19 Sump Pump:

Yes - The sump pump installed is functional. The presence of a sump pump does not indicate there is a need for it. This inspection does not verify the existence of or effectiveness of any subslab or perimeter drainage system. There is a submersible type sump pump installed. There is a battery backup installed. This will be of benefit should the electric fail, especially during a rainstorm.

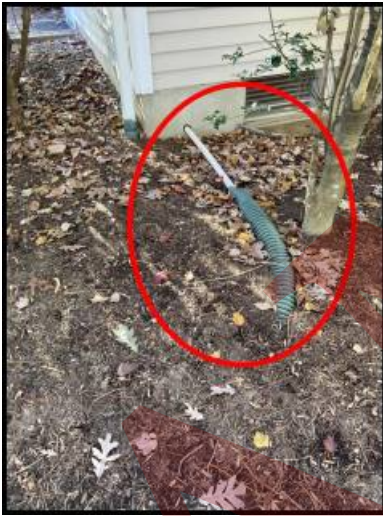
Action Necessary - The drainage line from the sump pump is installed in such a manner that water is not carried far enough away from the structure. The drain goes into an underground system. I was unable to determine where it discharges and if it is functional. Water needs to flow away from the side of the house at least 6-10ft feet.

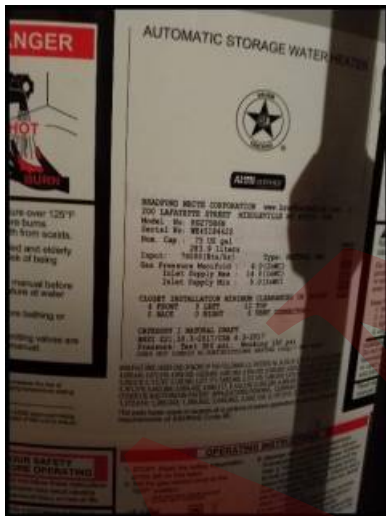
8.22 Model/ Serial Number/ Size:

System is Bradford White.
 Model #: RG275H6N
 Serial #: WE45184622
 Date of Mfg: May 2020.

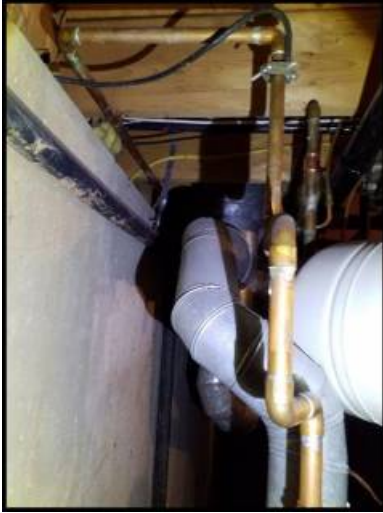
8.28 Flue/Exhaust Pipe Condition:

The exhaust flue appears to be correctly installed.

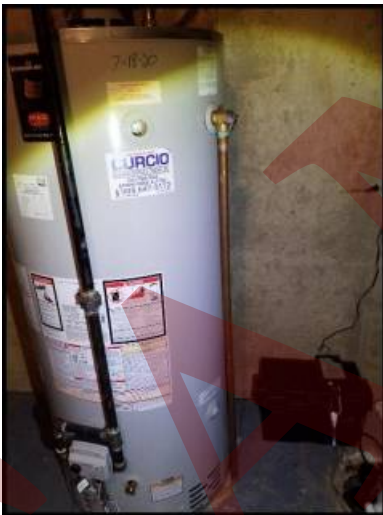
The temperature and pressure relief valve is of the correct rating for the water heater.

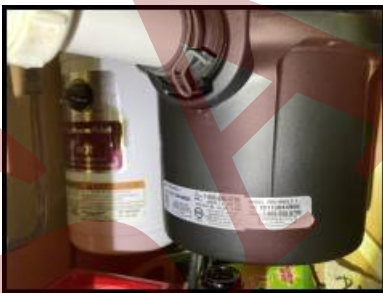
9.4 Food Waste Disposal:

System is Badger. The food waste disposal appears to be functional. No food was ground up in this inspection. The inspector was unable to determine if the unit will grind food waste adequately.

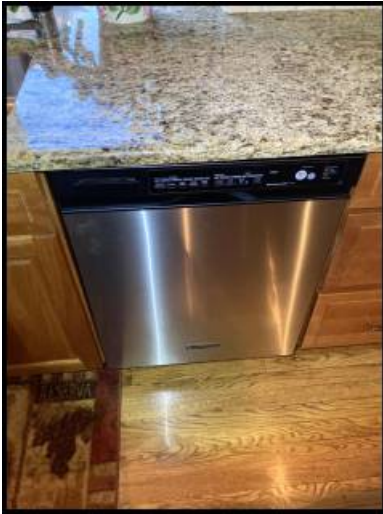
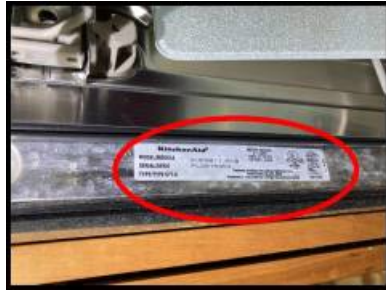
9.5 Dishwasher:

System is KitchenAid. The dishwasher appears to be functional. The dishwasher was tested on one cycle, and it appeared to function normally. This dishwasher is a multi-cycle unit, but only one cycle was tested. This does not imply that the other cycles also work, nor does it imply that the dishwasher will clean the dishes to your requirements.

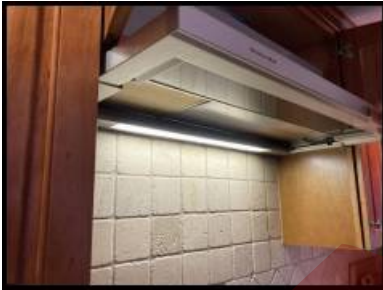
Action Required
9.6 Range Hood:

The exhaust hood is directly vented to the exterior of the structure. The range hood and exhaust fan appeared to work correctly on one or both speeds. There is a filter installed, and it will require periodic cleaning.

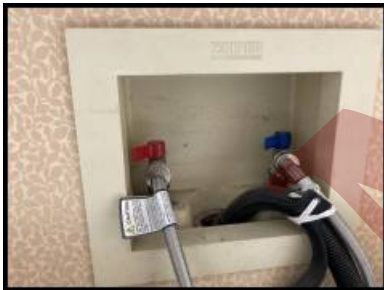
10.4 Washer Hookup:

Yes, There is a connection box installed in the wall with both hot and cold water and a drain pipe. The drain pipe was not flood tested.

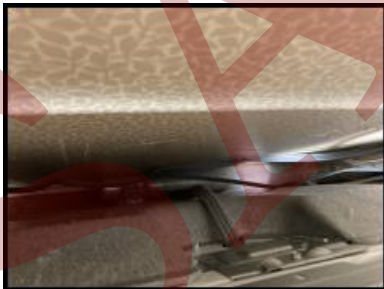
10.5 Dryer Hookup:

Yes - There is a 220/240-volt outlet provided for an electric dryer. If you intend to use a gas clothes dryer, you will need to have a gas line installed.

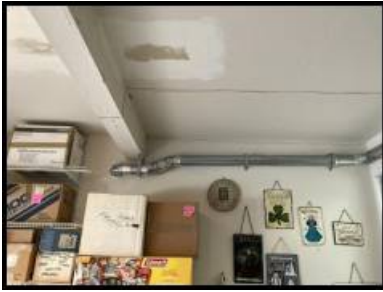
10.6 Dryer Ventilation:

The dryer ventilation as installed appears adequate. The vent hood outside is clean, and the flapper is functional.

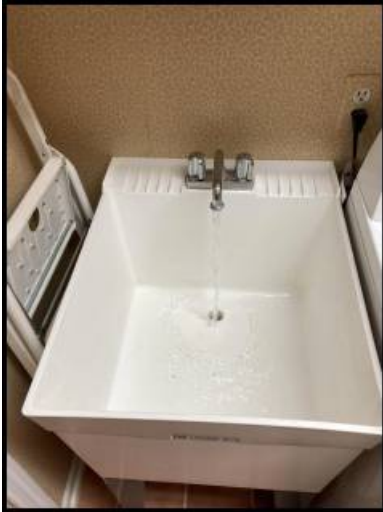
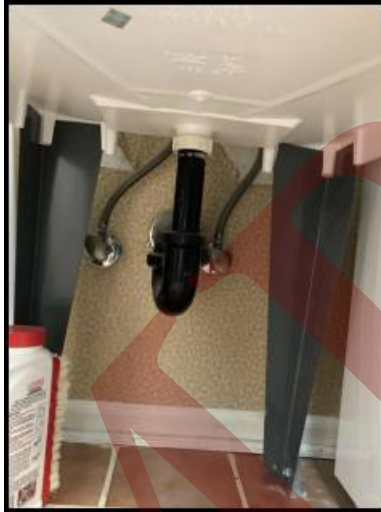
10.7 Laundry Basin:

Yes - There is a laundry basin installed. The unit is functional. No leaks were noted.

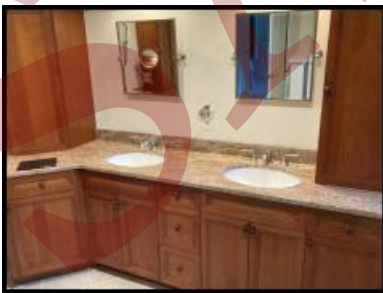
11.1 Vanity Cabinet:

The vanity cabinet and top in this bathroom are functional.

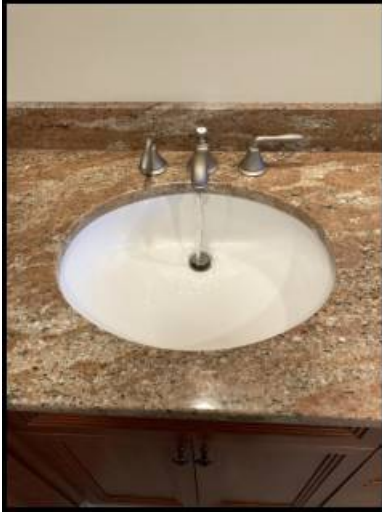
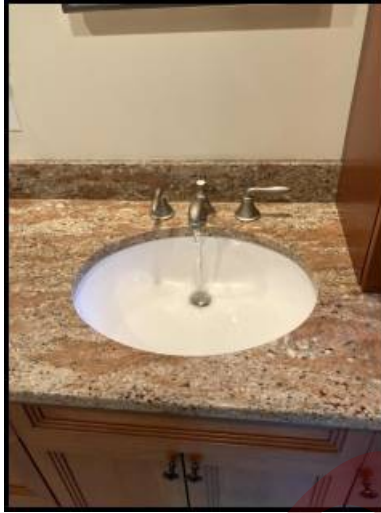
11.2 Basin and Drain Fixture:

The basin and drainage fixture appear to be fully functional.

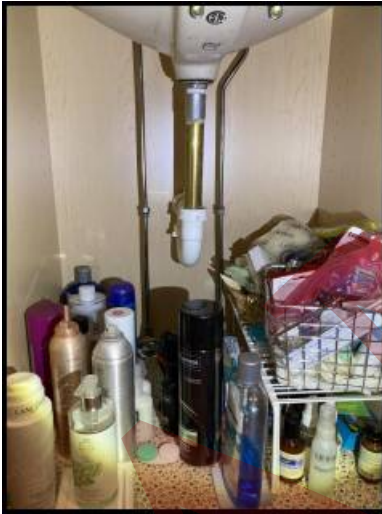
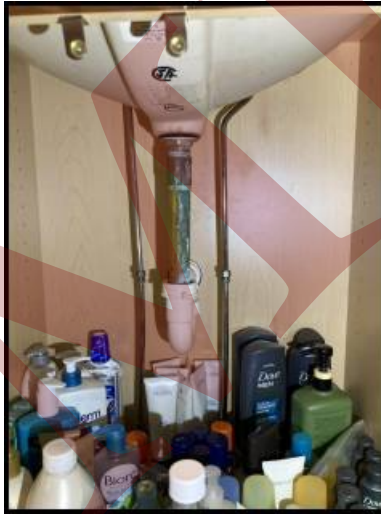
11.3 Faucet and Supply Lines:

Faucets and supply lines appear functional.

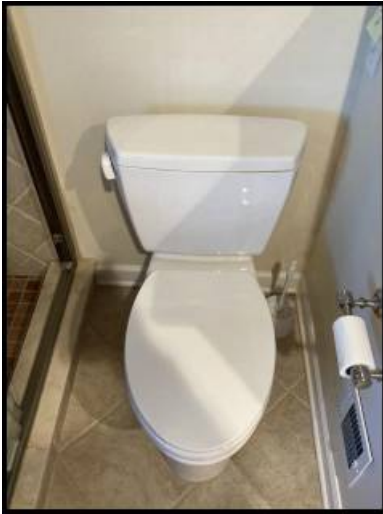
11.4 Toilet Condition

The toilet appears to be functional.

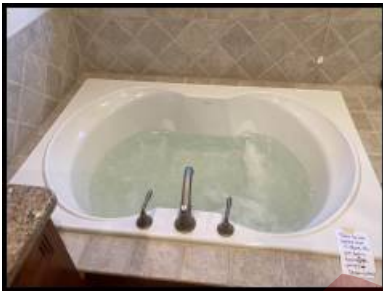
Action Required Maint Recommend
11.5 Tub:

There is a spa tub installed. The tub was filled with water and the jets activated to observe for proper action. The tub appeared to function properly.

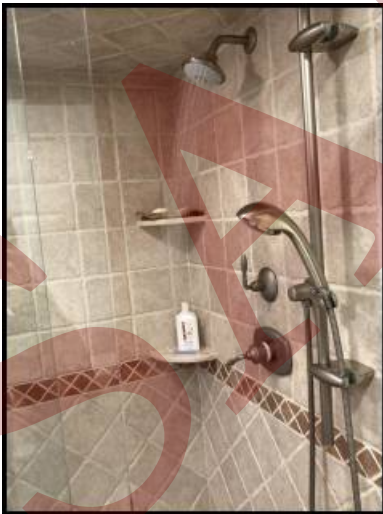
11.6 Shower/Shower Head and Mixing Valves:

Functional - The shower, shower head, and mixing valves are all performing as required.

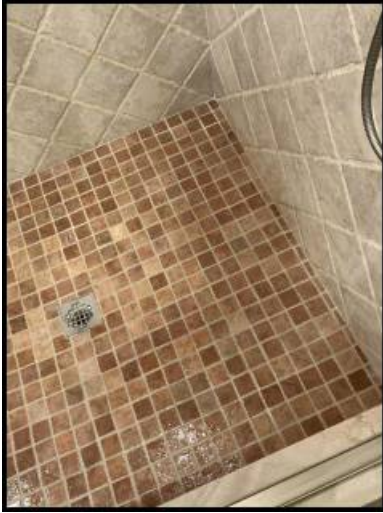
11.7 Shower Pan:

The shower pan does not appear to leak at this time. Disclaim - This is a visual inspection of the readily accessible portions of the shower stall and was not invasive. Therefore, it is a limited inspection and may not have noted any hidden defects. Flood testing of the shower pan was not included as part of this inspection.

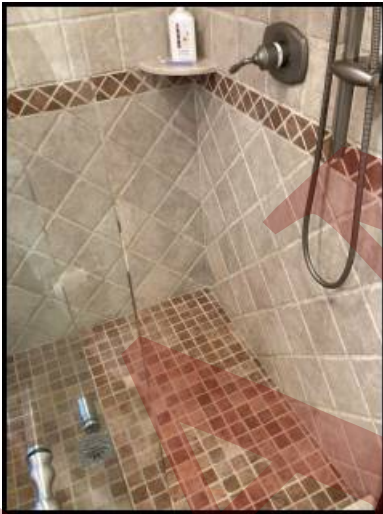
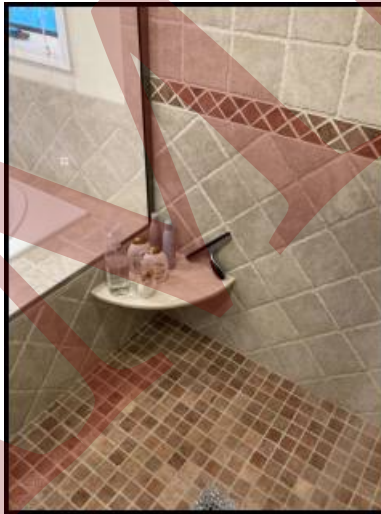
11.8 Tub & Shower Walls:

The walls appear to be in functional condition.

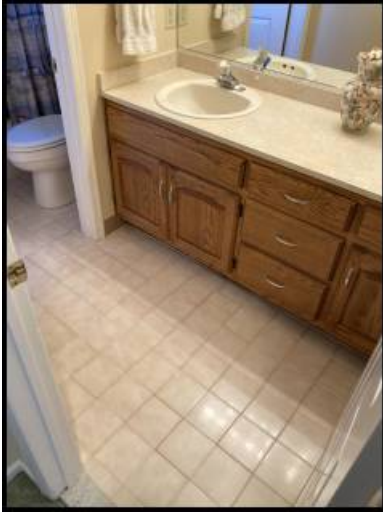
11.14 Vanity Cabinet:

The vanity cabinet and top in this bathroom are functional.

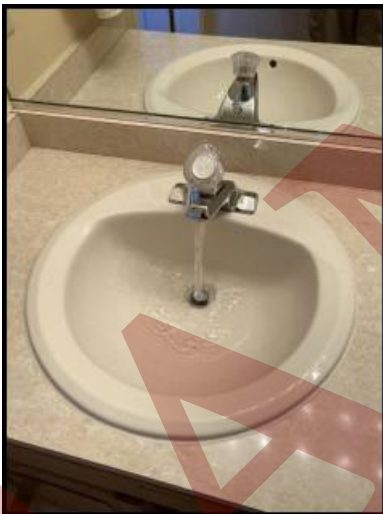
11.15 Basin and Drain Fixture:

The basin and drainage fixture appear to be fully functional.

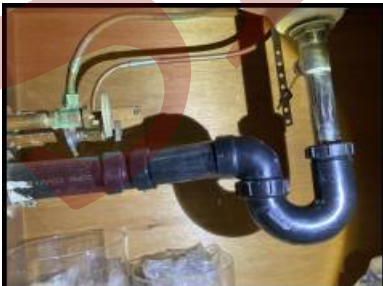
11.16 Faucet and Supply Lines:

Faucets and supply lines appear functional.

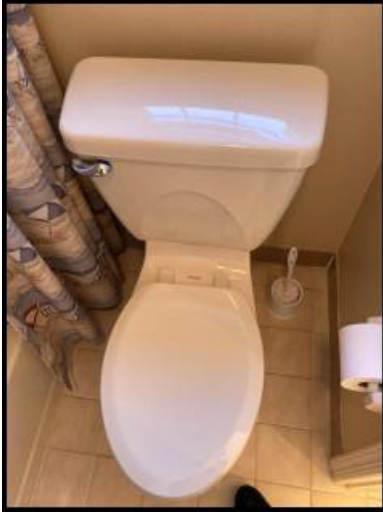
11.17 Toilet Condition

The toilet appears to be functional.

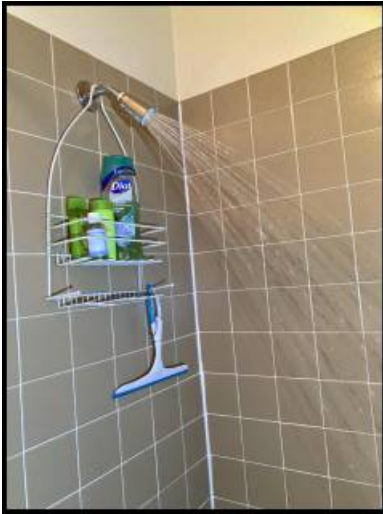
11.20 Shower/Shower Head and Mixing Valves:

Functional - The shower, shower head, and mixing valves are all performing as required.

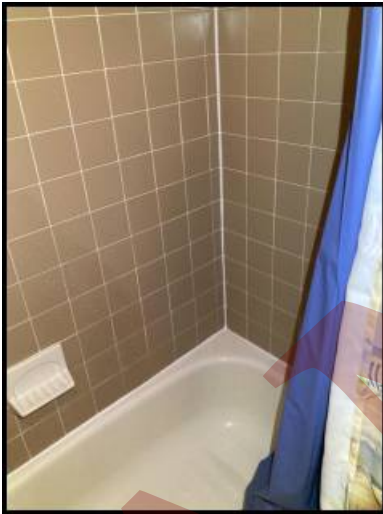
Action Required Maint Recommend
11.21 Tub & Shower Walls:

The walls appear to be in functional condition.

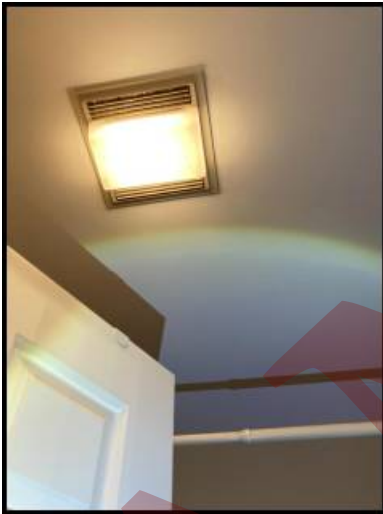
11.27 Ventilation Fans:

There is an exhaust fan installed in this bathroom, and it is functional.

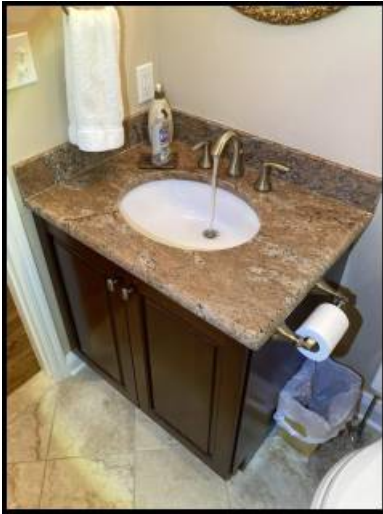
11.28 Vanity Cabinet:

The vanity cabinet and top in this bathroom are functional.

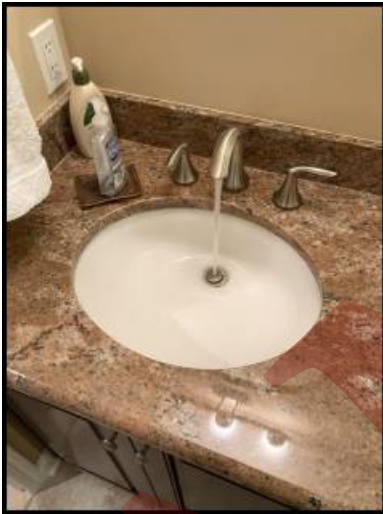
Action Required Maint Recommend
11.29 Basin and Drain Fixture:

The basin and drainage fixture appear to be fully functional.

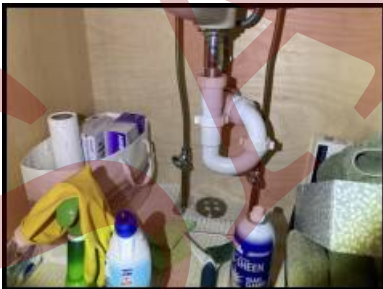
11.30 Faucet and Supply Lines:

Faucets and supply lines appear functional.

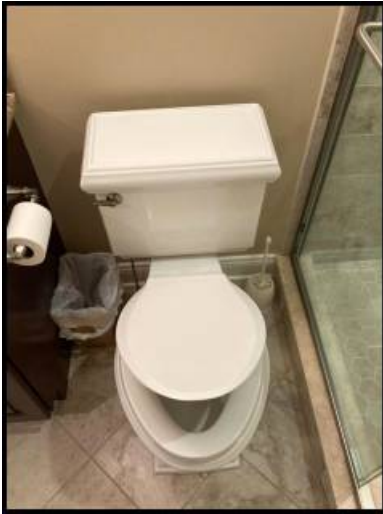
11.31 Toilet Condition

The toilet appears to be functional.

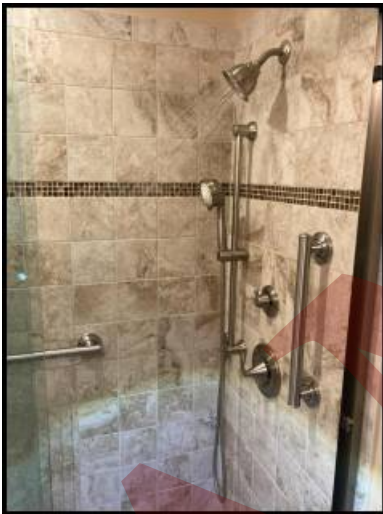
11.32 Shower/Shower Head and Mixing Valves:

Functional - The shower, shower head, and mixing valves are all performing as required.
