Remedy Inspections LLC

Sample Inspection Report

123 Main St USA
Any Town NJ 07000

January 1, 2022

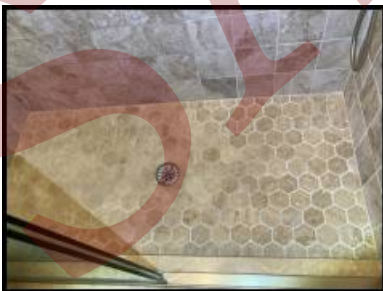
11.33 Shower Pan:

The shower pan does not appear to leak at this time. Disclaim - This is a visual inspection of the readily accessible portions of the shower stall and was not invasive. Therefore, it is a limited inspection and may not have noted any hidden defects. Flood testing of the shower pan was not included as part of this inspection.

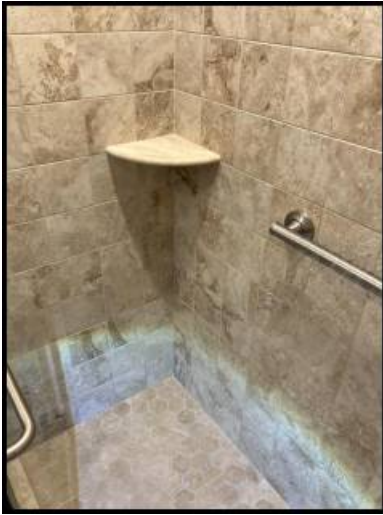
11.34 Tub & Shower Walls:

The walls appear to be in functional condition.

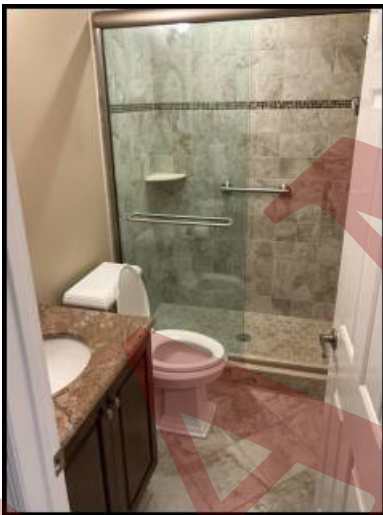
11.36 Glass Tub/Shower Door:

Yes, Safety Glass? - There is a set of sliding glass doors installed. I was not able to determine if they are made of safety glass.

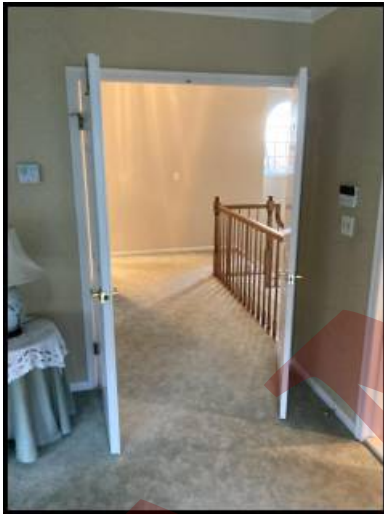
12.1 Entry Door:

The entry door to this bedroom is functional.

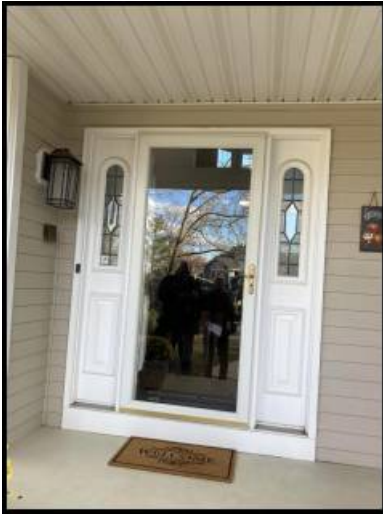
13.1 Front Entry Door:

The main entry door to the structure is in functional condition. There is a deadbolt installed on the main entry door, and it is operational. This is a recommended safety feature.

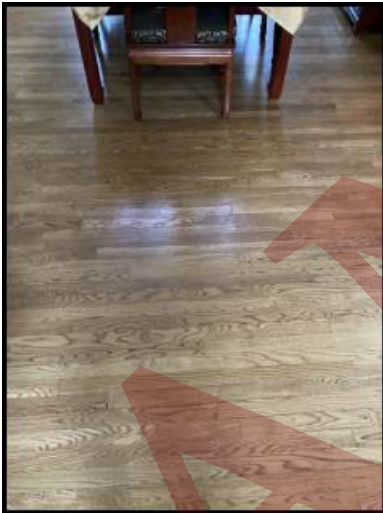
13.3 Entry Floor:

The entry floor material appearance is good and material is functional. The floor covering material is wood.

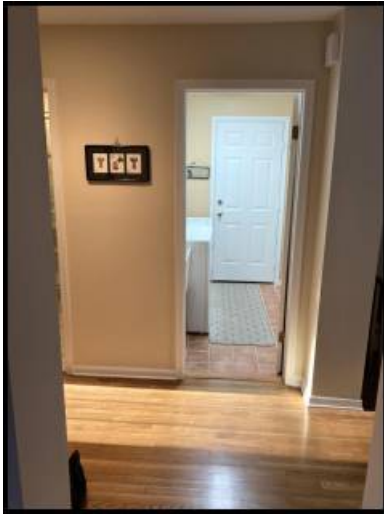
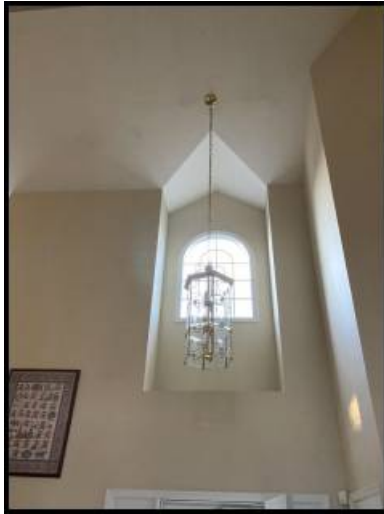
13.4 Main Hallway:

The main hallway walls and floor are without significant issues.

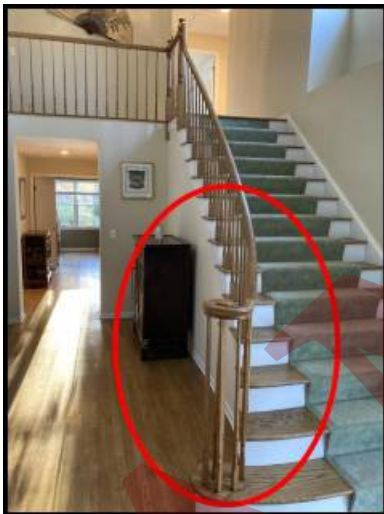
Attention Needed - Some portion of the main stairway needs attention. Newel post needs tightening. It is loose.

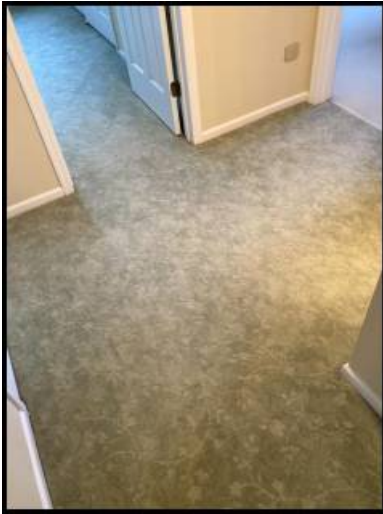
13.6 Upper Level Hallway:

The upper level hallway walls and floor are without significant issues.

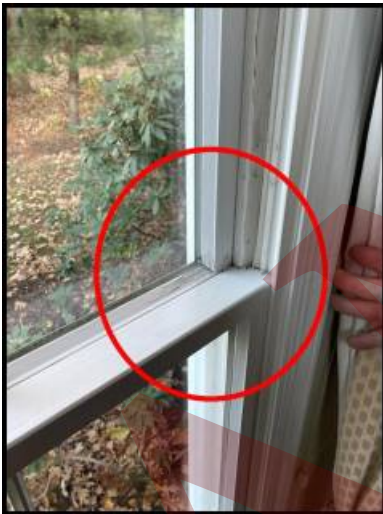
Attention Needed - At least one window or associated hardware in this room needs attention. The window sash is showing evidence of rot in the upper corner. While dry at the time of the inspection this sash should be replaced.

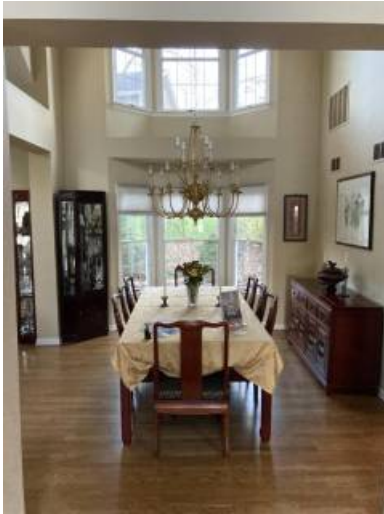
13.10 Walls:

The walls in the room appear to be functional.

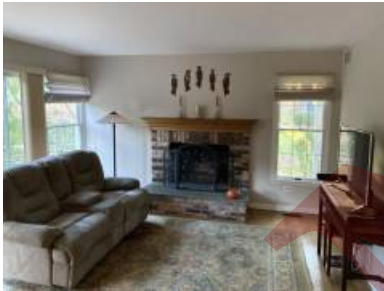
13.12 Walls:

The walls in the room appear to be functional.

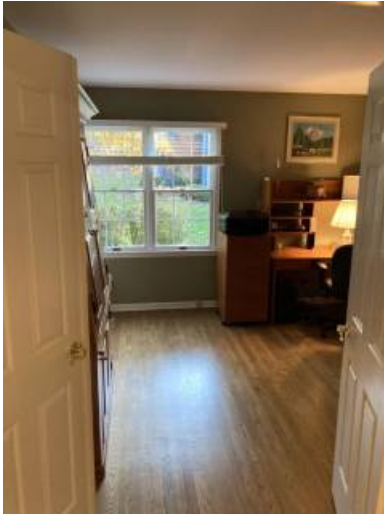
13.14 Entry Door:

The entry door to this bedroom is functional.

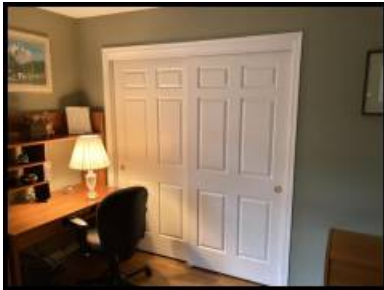
The closet is functional and of average size.

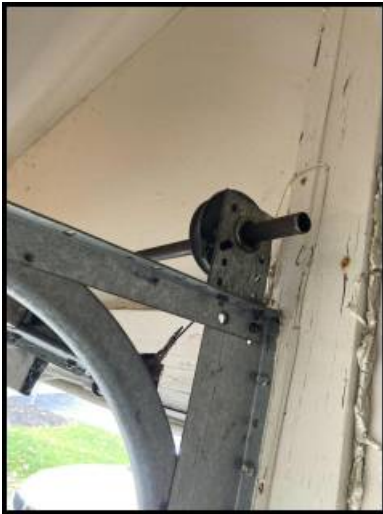
14.4 Overhead Door and Hardware Condition:

The overhead door is in satisfactory condition, and it is functional. There is a safety wire installed that will prevent the springs from swinging free when they fail. That could cause damage or injury.

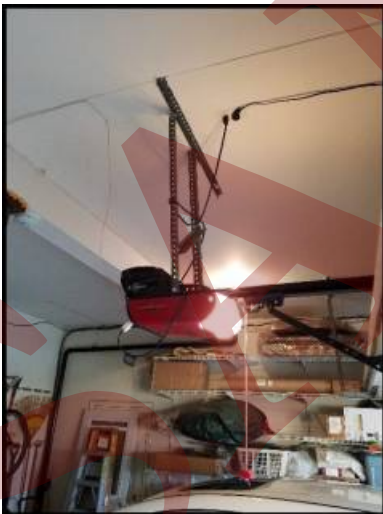
14.5 Automatic Overhead Door Opener:

The overhead door opener appears to function appropriately.

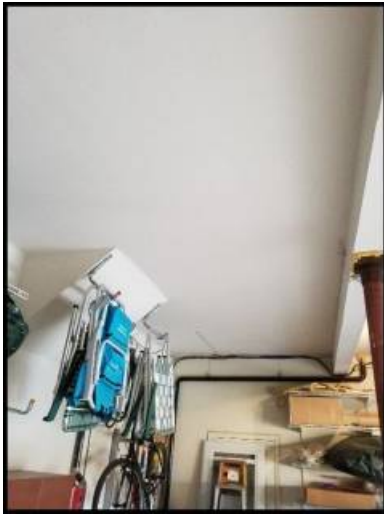
Yes - There appears to be a fire rated separation between the garage ceiling and the living areas above.

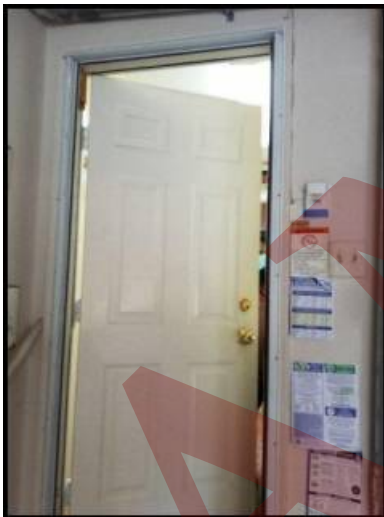
14.8 Fire Rated Entry Door to Structure:

Yes - There is a fire rated door separating the garage from the living areas of the house.

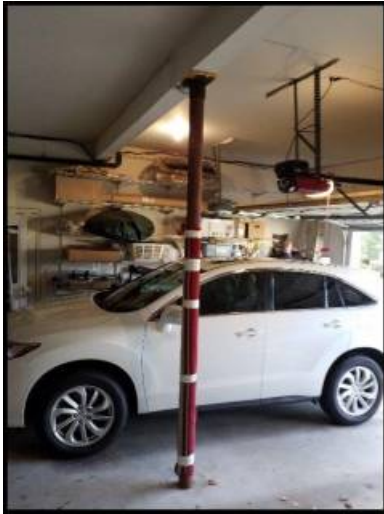
14.10 Posts Condition:

There is a post supporting an overhead beam in the garage. It appears to be adequately installed.

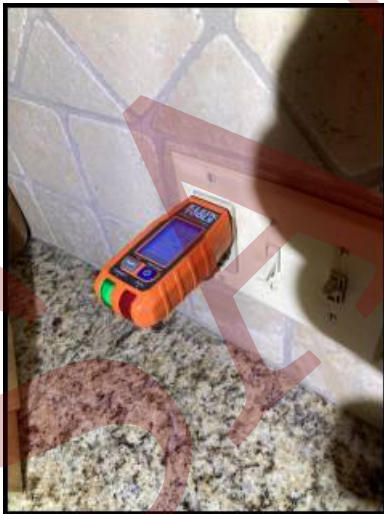
16.1 Kitchen Interior

The outlets tested in the kitchen are correctly wired and grounded. As a whole, outlets throughout the room are in serviceable condition. There is a Ground Fault Circuit Interrupt outlet installed and functional above the kitchen countertop. It is in the area within a 6 foot reach of the sink.
